Damage Behavior of Composite  
Structures and Joints  
at Room and Elevated Temperatures

Final Report: Phase I

Contract No: DAAE07-96-C-X-121

U.S. Army Tank-Automotive Research,  
Development, and Engineering Center  
Detroit Arsenal  
Warren, Michigan 48397-5000

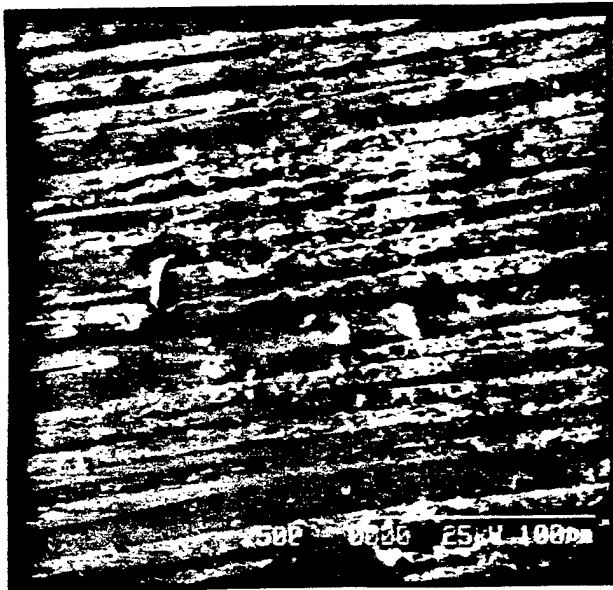
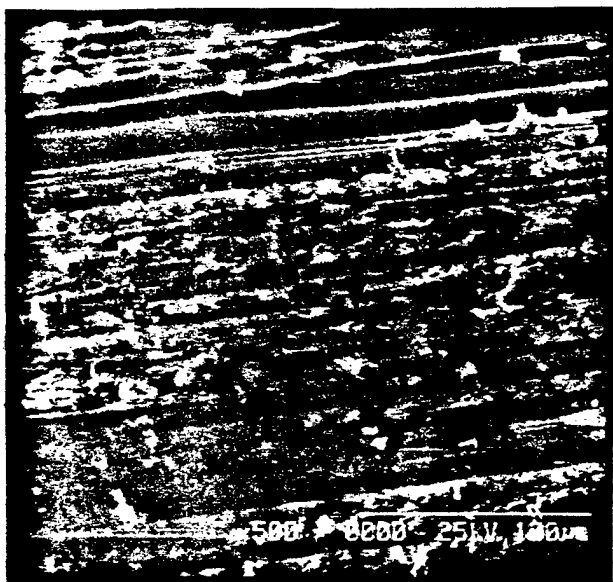
(a) No Load

(b) at 930 MPa

(c) At 1300 MPa

(d) at 1480 MPa  
Fiber breakage

Fig.6 Microphotographs showing fiber breakage and interfacial debonding.

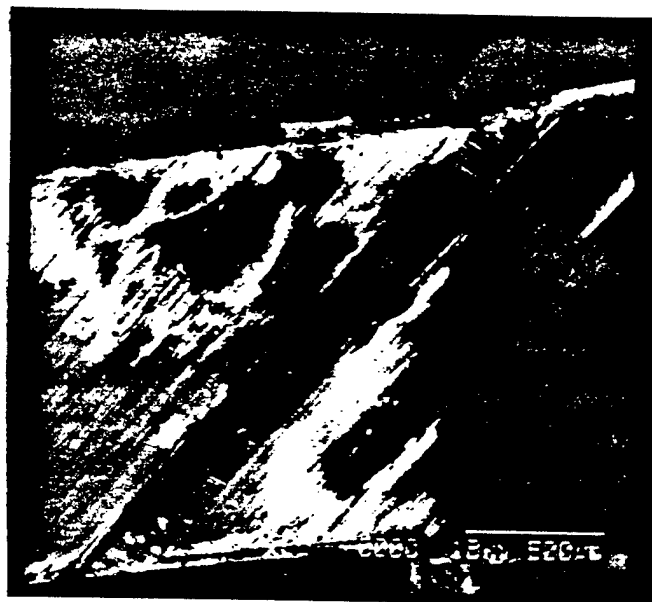
Fig.7 Composites failure at  $\pm 45^\circ$  (at 80 MPa)
